# Move-in inventory

Schedule of condition recorded at the start of the tenancy

| PROPERTY | Alder Row, Flat 2<br>Flat 2, 14 Alder Row<br>Bedminster<br>Bristol BS3 4QP |
| DATE RECORDED | 11 April 2026 |

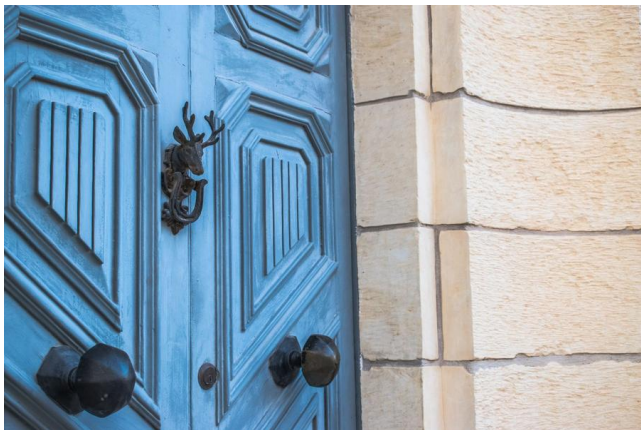
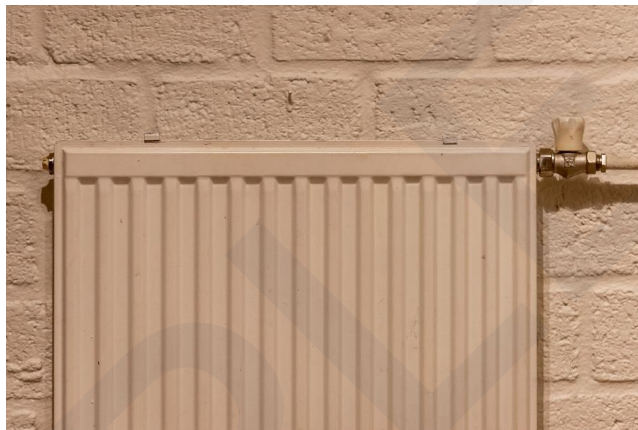
Front door opens, closes and locks correctly on both the latch and the deadlock. Paintwork sound. Light scuffing to the skirting board immediately behind the door, pre-existing and photographed. Carpet clean with no marks or burns. Smoke alarm tested and working.

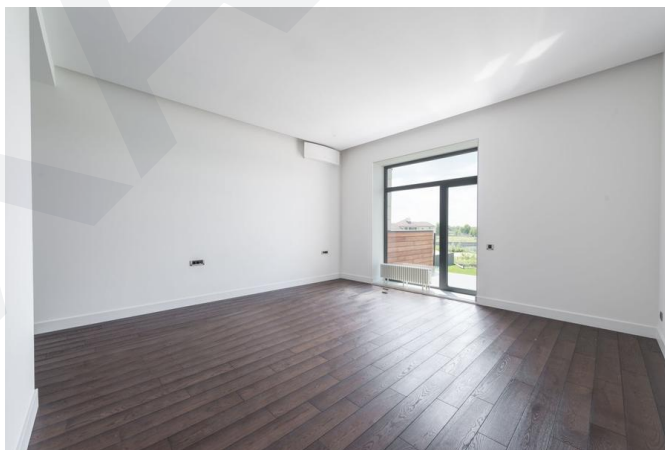
Photo 2.1

Walls freshly painted in a neutral white, no marks or fixings. Floor in good condition throughout with light wear in the traffic line to the balcony doors. Radiator warms fully and shows no signs of leaking at either valve. Curtain track secure; curtains clean and undamaged.

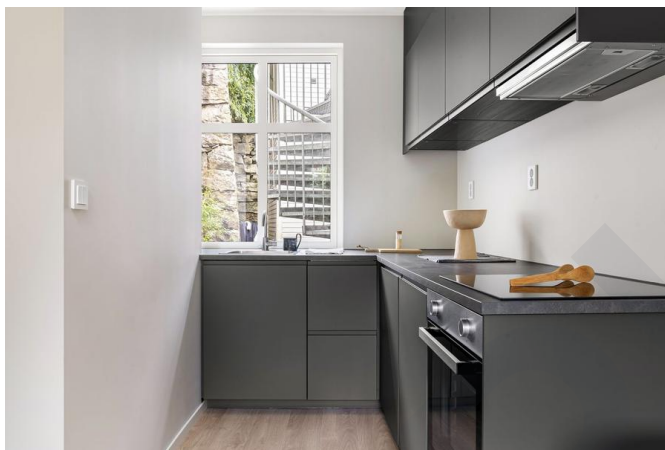
Photo 3.1

Units, worktops and splashback all clean. Oven, hob and extractor all tested and working; oven interior clean. Small chip to the worktop edge to the left of the sink, pre-existing and photographed. Sink and tap run freely with no leak under the unit.

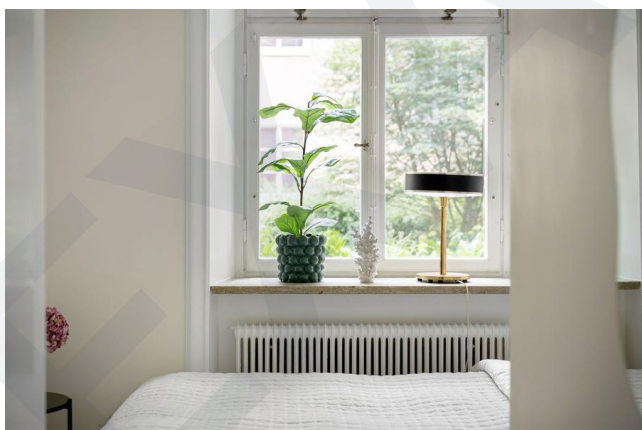
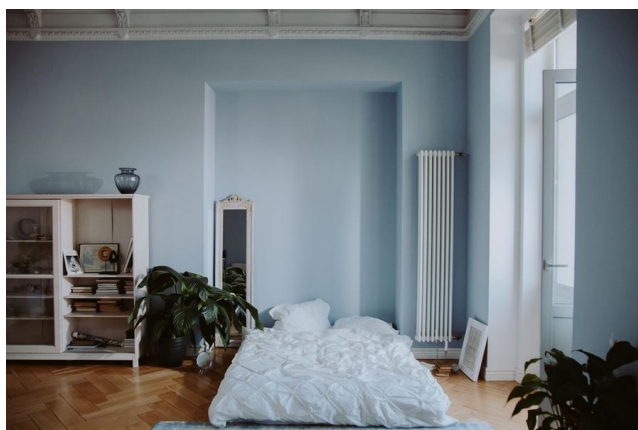
Decoration sound throughout. Window opens, closes and locks; no draught or condensation staining to the reveal. Radiator beneath the window warms fully. Floor clean and unmarked.

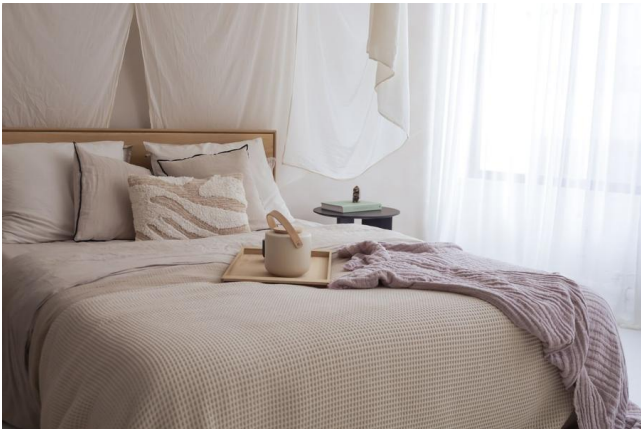
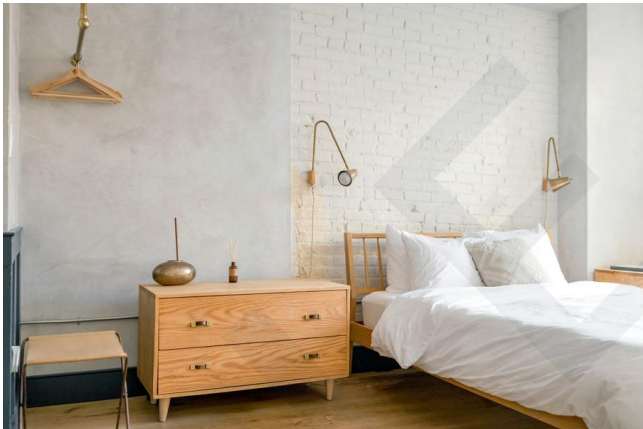
Smaller rear bedroom. Decoration and floor both in good order. Wardrobe doors run correctly on their tracks.
